THERMAL BRIDGES IN CONCRETE STRUCTURES: ANALYSIS OF THE CONDITIONS OF FILAMENTAL FUNGI DEVELOPMENT

PONTES TÉRMICAS EM ESTRUTURAS DE CONCRETO: ANÁLISE DAS CONDIÇÕES DE FORMAÇÃO DE FUNGOS FILAMENTOSOS

Julye Moura Ramalho de Freitasⁱ

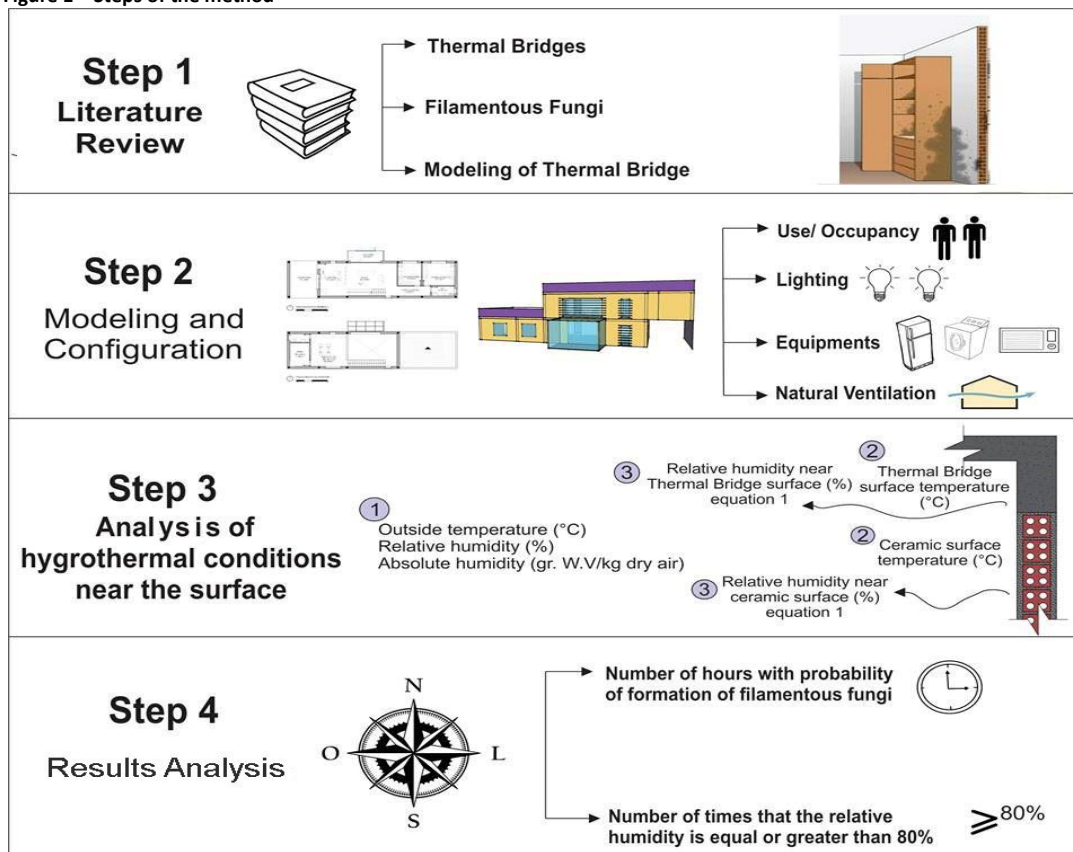
Figure 1 – Steps of the method

The research approach is quantitative and uses computer simulation. The method was divided into four steps (Figure 1). First, a literature review about thermal bridges and filamentous fungi was performed in the first step. In the second step, the building was modeled, and schedules were set for use and occupancy, lighting and equipment, materials, and natural ventilation. The third step consisted of analyzing the thermo hygrometric conditions on the envelope's inner surface and identifying the period of the year susceptible to the formation of filamentous fungi. Two building envelope conditions were tested: a highly insulated envelope and a poorly insulated envelope. The results were analyzed and discussed in the fourth step.

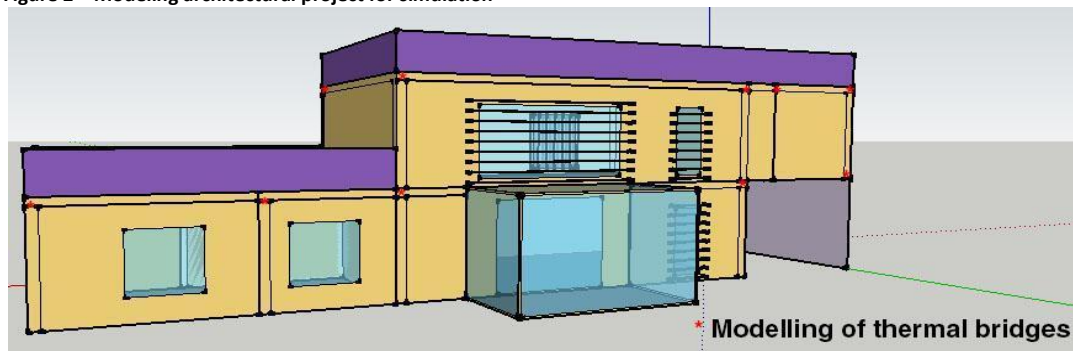
Figure 2 – Modeling architectural project for simulation

The residential building designed by Dalbem (2015) was used to develop the analysis (Figure 2). The building was designed to meet the Passive House criteria, but the walls' thermal transmittance was changed in this research.

The building was modeled through the graphical interface for SketchUp 2015 called Legacy Open Studio 1.0.13 plugin. To configure different materials and compositions for thermal bridges and outdoor walls, the structure surfaces of the building were individually configured. The "New Construction Stub" command set the thermal bridge, allowing different configurations to be set for the rest of the building enclosure (Figure 2).

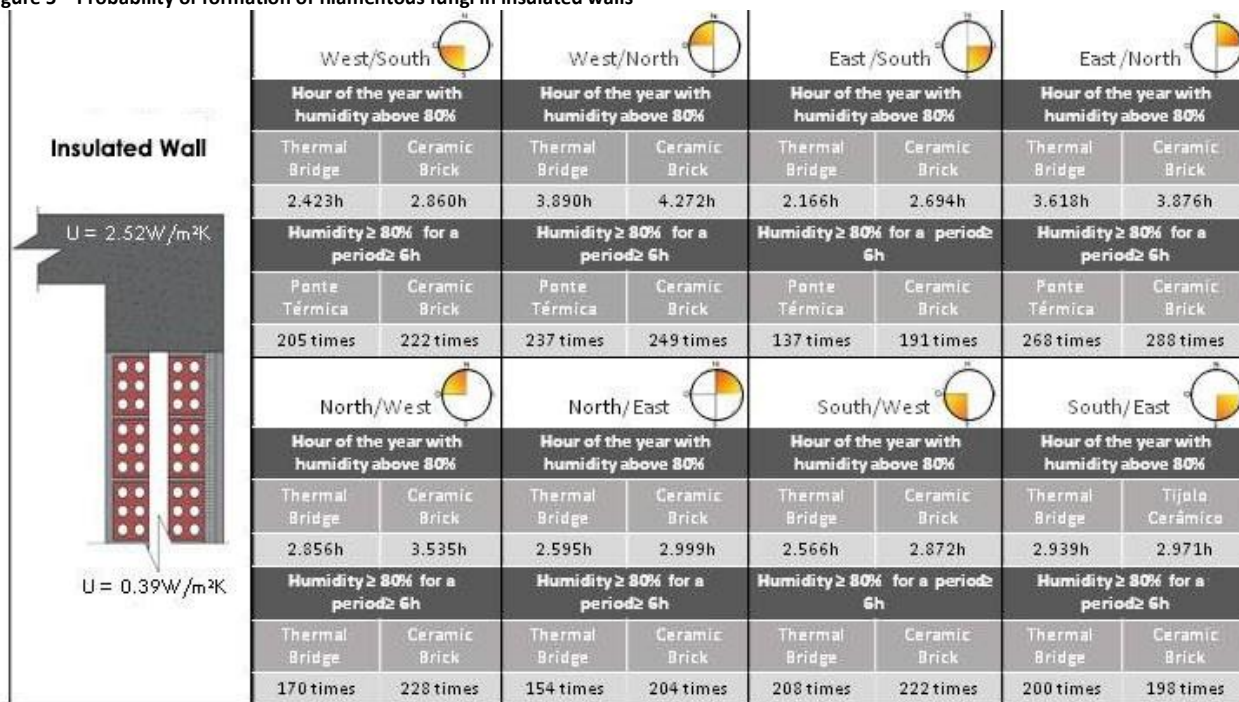
Figure 5 – Probability of formation of filamentous fungi in insulated walls

Figure 3 indicates the surfaces analyzed by the study. Figures 4 and 5 show the possibility of filamentous fungi formation on the inner envelope wall surfaces for the ceramic brick surface and the reinforced concrete structure (thermal bridge) of each façade. The results correspond to the number of hours per year when the air relative humidity is equal to or higher than 80%. The number of times that the surface humidity was equal or higher than 80% for a period equal or longer than six hours.

By varying the envelope thermal transmittance, we could verify that the probability of filamentous fungi formation on the thermal bridges was higher for the insulated case. There is a significant thermal transmittance difference between the reinforced concrete of the structure and the ceramic brick enclosure with insulation, resulting in a higher temperature difference near those surfaces. Meanwhile, in buildings with no insulation, the temperature and the relative humidity near the surfaces remained similar.

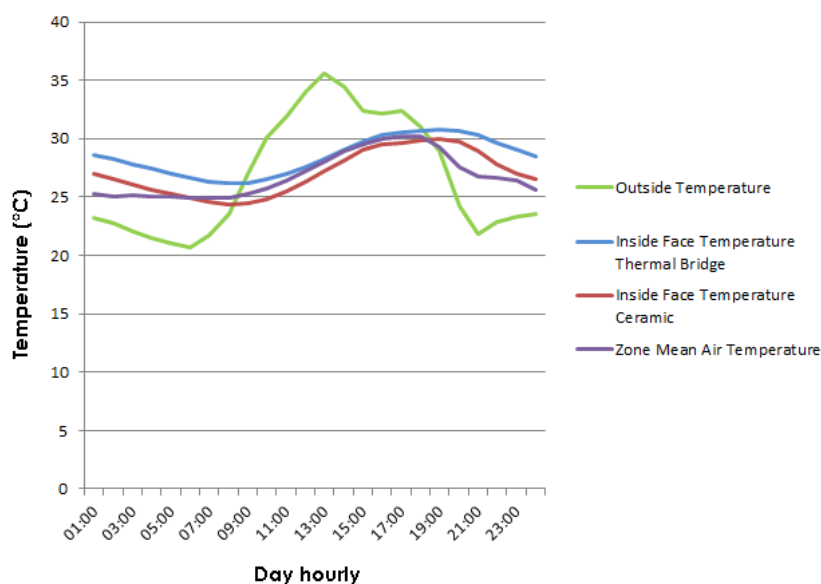
Figure 6 – South-East façade: Temperatures – Summer day U = 2.49 W / (m²K)

Figures 6, 7, 8, and 9 show the envelope inner wall surface temperature and humidity of the South-Eastern façade for the model with no insulation for summer and winter days.

In the summer (Figure 6), the temperature near the thermal bridge's surface is higher than the temperature near the ceramic brick enclosure during the whole day, which will cause a higher relative humidity near the ceramic wall (Figure 7). In winter (Figure 8), the temperature near the thermal bridge is also higher, but only for the period from 3:00 p.m. to 5:00 p.m., which causes the air relative humidity curve (Figure 9) to be similar between the two surfaces.

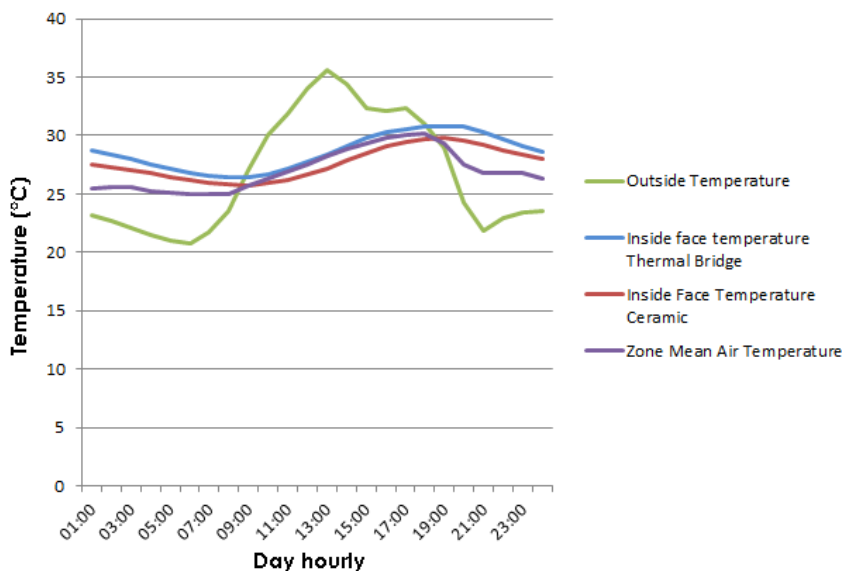
Figure 10 – South-East façade: Temperatures – Summer day U = 0.39 W / (m²K)

Figures 10, 11, 12, and 13 show the envelope inner wall surface temperature and humidity of the South-Eastern façade for the model with insulation for summer and winter days.

The insulated building behavior in summer was similar to the behavior of the building with no insulation. Besides the significant temperature difference near the thermal bridge's surface (Figure 10), it remained higher than near the ceramic brick surface, so the relative humidity near the ceramic wall was higher (Figure 11). In winter, the temperature near the ceramic brick surface (Figure 12) was higher than near the thermal bridge's surface, causing higher relative humidity near the structure (Figure 13). In the building with insulation, the air relative humidity near the surface of the thermal bridge was higher in the Eastern façade on both sides of the building most of the day.

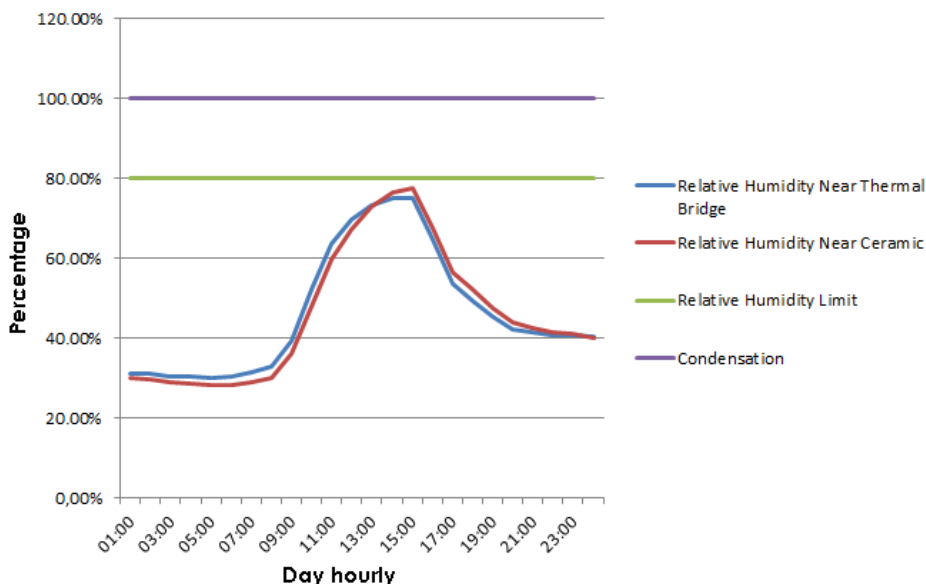
Figure 14 – East-South façade: Relative humidity near surfaces – Winter Day U = 0.39 W / (m²K)

Figures 14 and 15 show the relative humidity of the East-South and East-North façades for the typical winter day.

In summer, the model's East façade with no insulation presented different behavior compared to the other solutions. Since the reinforced concrete structure's thermal transmittance was higher than that of the insulated wall, the thermal bridge temperature was lower, increasing the relative humidity near the reinforced concrete structure's inner surface.
